46 HALSEY STREET

SOUTH BUNBURY

PRE PURCHASE INSPECTION

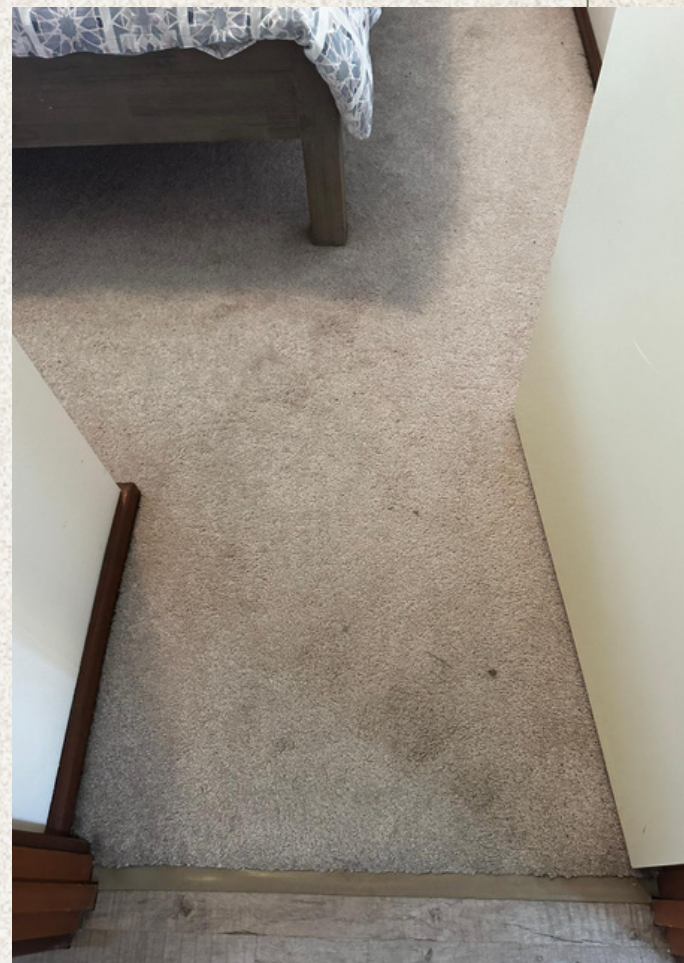
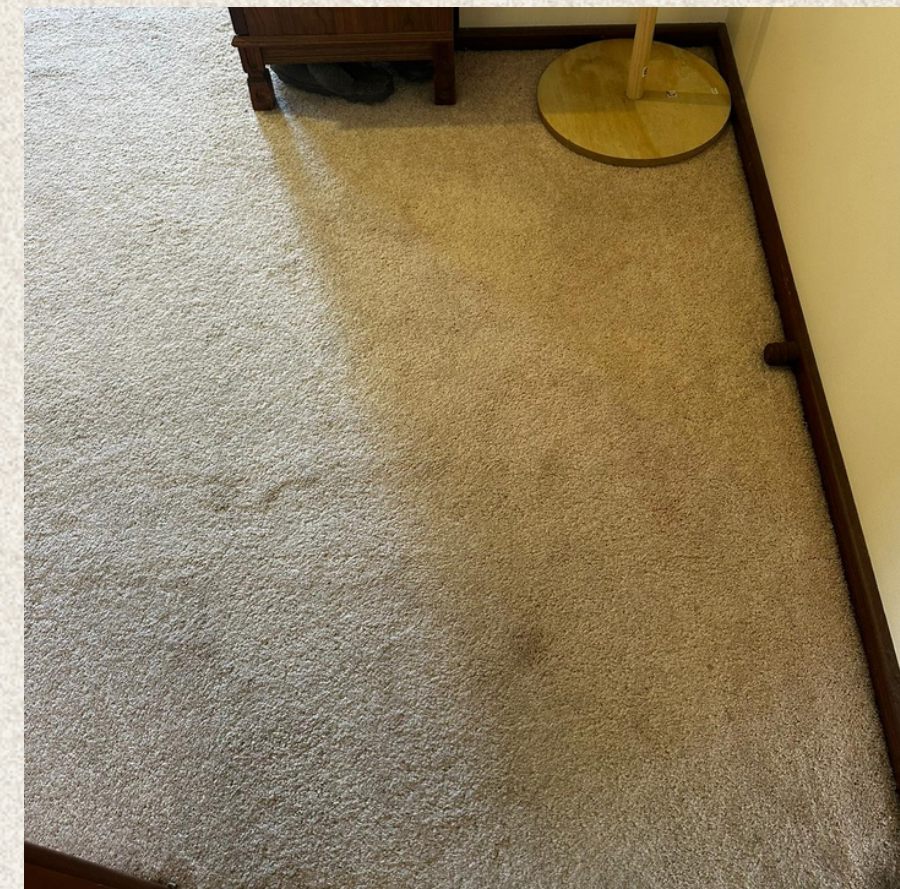
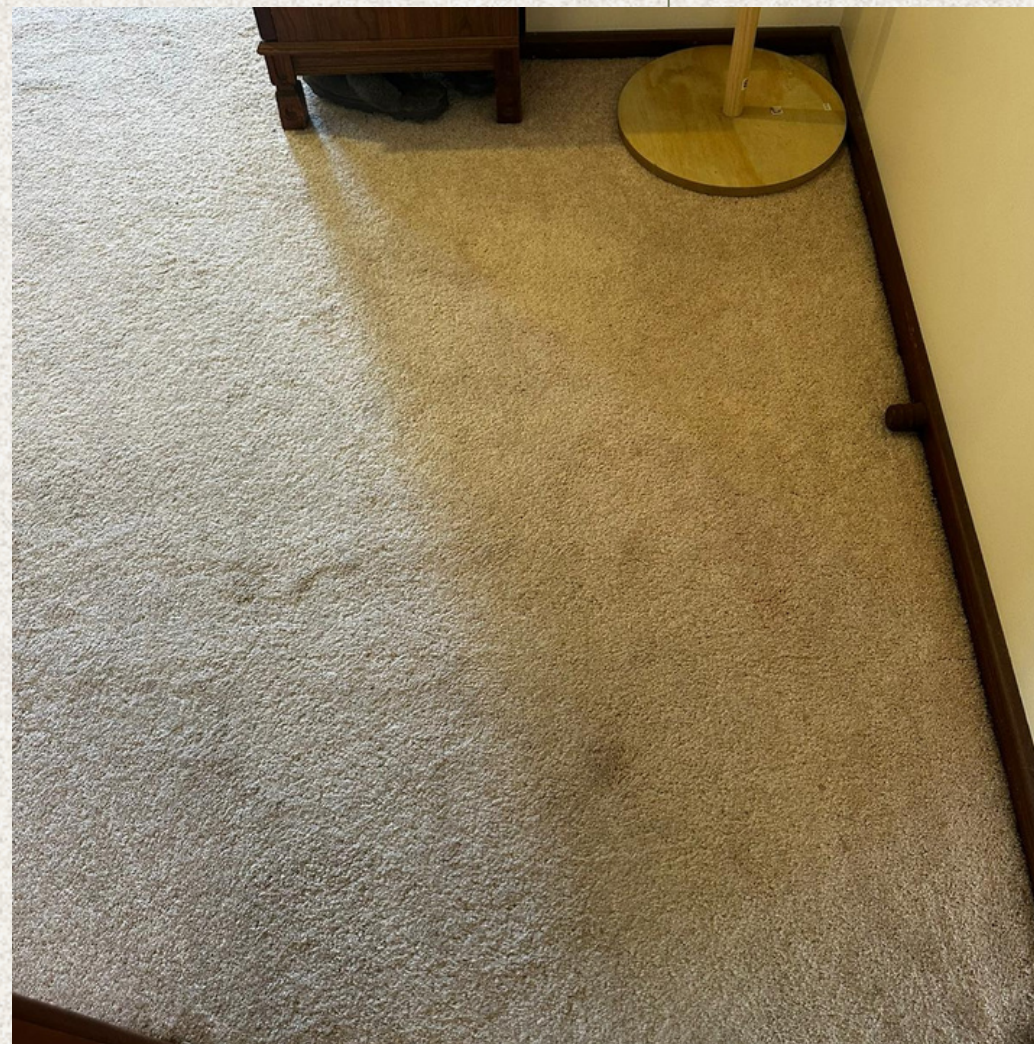
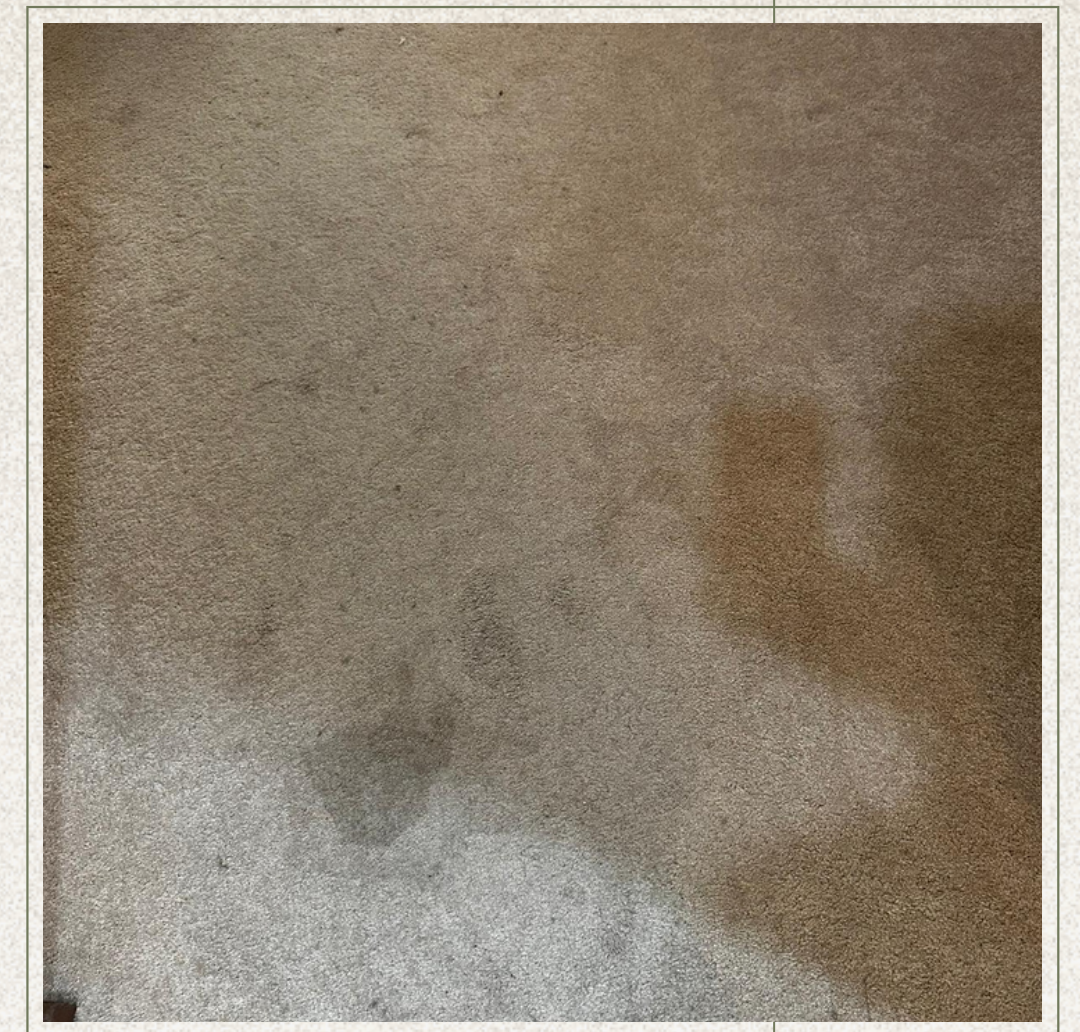
carpet is heavily stained

The carpet at the property is heavily stained beyond cleaning repair and it would be recommended to replace this to achieve maximum rental value. This in turn will present the home in a much better light.

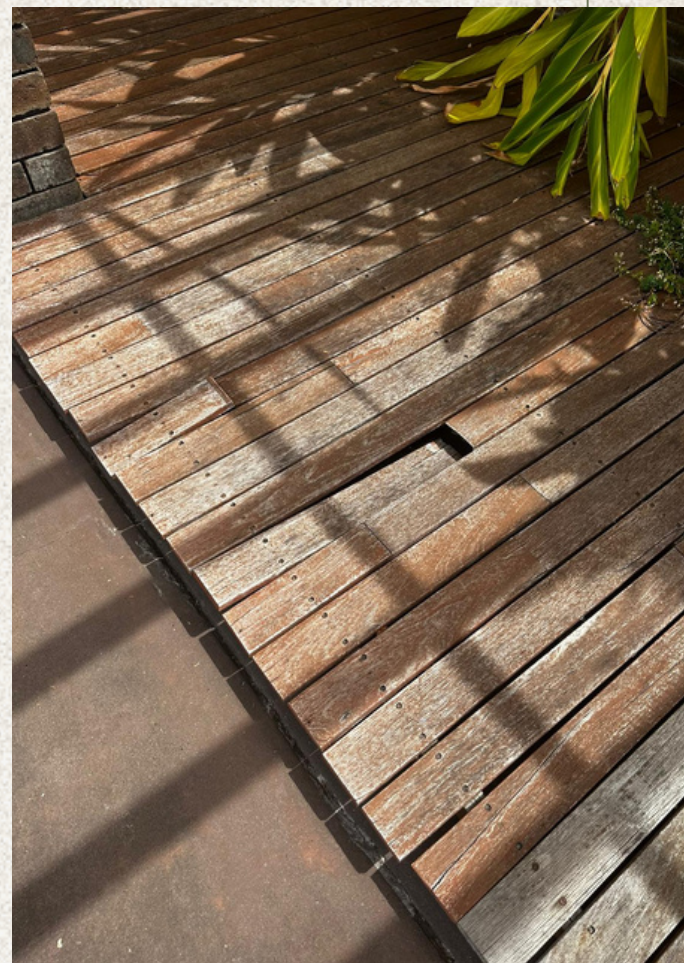
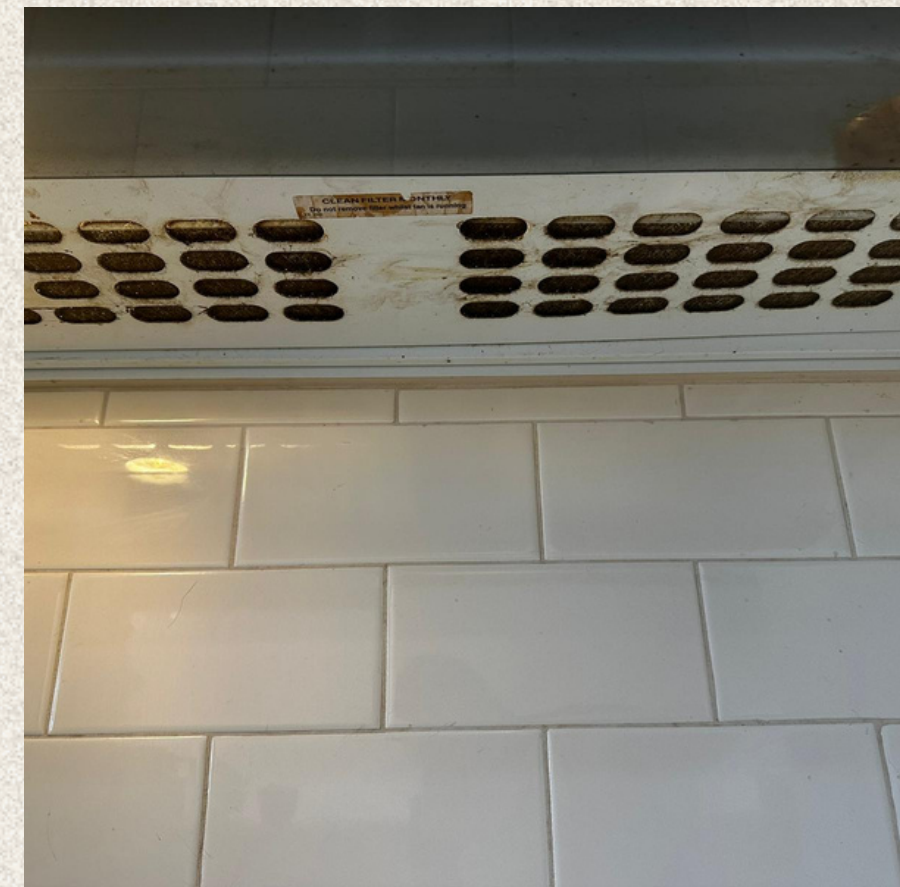
Decking repair

Decking to the rear left hand side of the property needs to be fixed as it will become a safety issue when tenanting the property

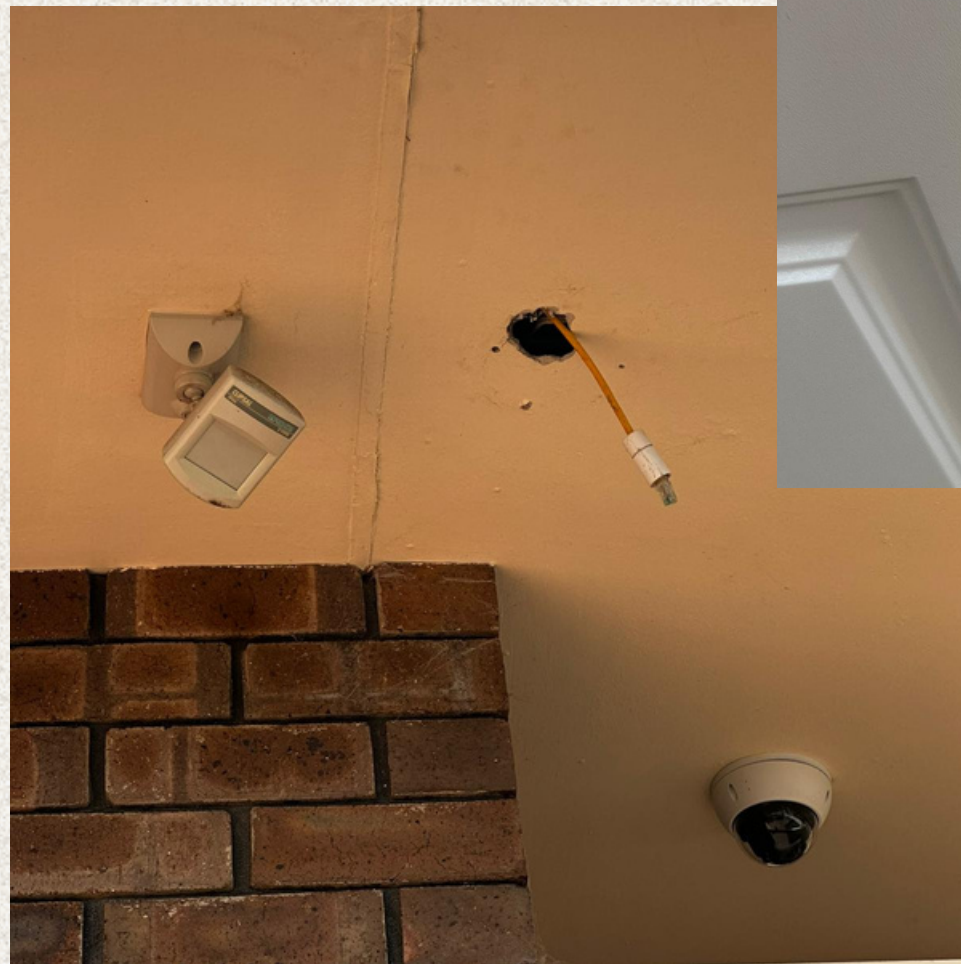
**WIRE HANGING FROM EAVE TO THE REAR LEFT
HAND SIDE OF THE PROPERTY**
